BETTY'S BAY FLOODS OF DECEMBER 2013 / JANUARY 2014:

RECOMMENDATIONS FOR ACTION AIMED AT PREVENTING DAMAGE DURING FUTURE EPISODIC FLOOD EVENTS

(Allan Heydorn – 21 January 2014)

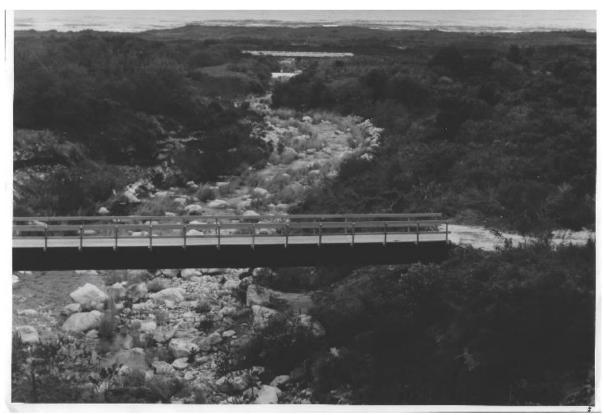
Figure 1:Olive May Porter Bridge across Disa River. Date ± 1966.

(This figure was dated by Roger Porter. It shows the newly built Olive May Porter Bridge and the Disa River \pm 1966. Note that the river bed is virtually clear of palmiet growth.)

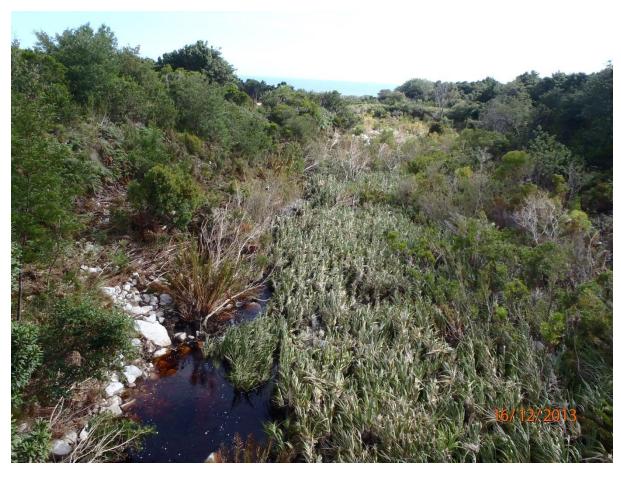
Figure 2:

Disa River channel on the upper floodplain, in the HPNBG. Note the dense growth of Palmiet undamaged by the floods of mid-November 2013. The photo was taken from the Olive May Porter Bridge on 16.12.2013. The lawn of the amphitheatre of the HPNBG can just be discerned at the top/middle of the photo.

- 1. As the figures below show, rampant palmiet growth is the major cause of flooding on the upper and lower floodplains (Figs 1, 2 & 3). The palmiet must therefore be cleared from theriver channels from the Olive May Porter Bridge to the mouth of the former major flow channel at the western end of Marine Drive (please refer to Fig 4). If the bulk of floodwaters are carried to the sea rapidly, the extent to which water levels can rise during flood conditions, will be drastically reduced. However, it must be accepted that clearing of the main flow channels will have to be repeated every few years.

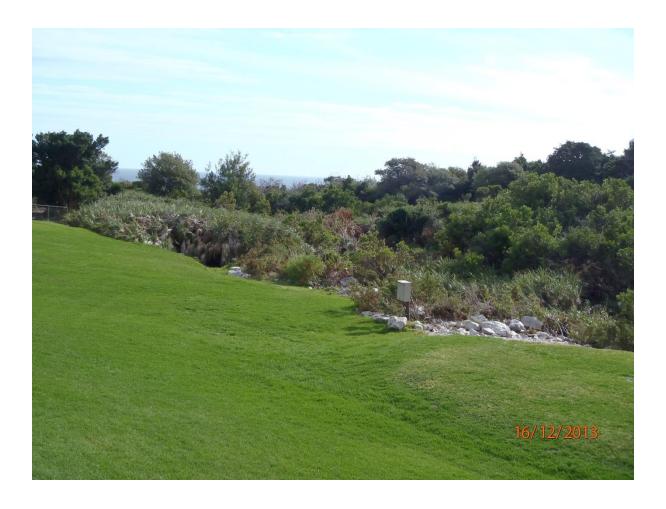
Figure 3:

The lower corner of the amphitheatre area of the Harold Porter National Botanic Garden showing the plug of palmiet which causedflood waters to overflow into the lower portion of the gardens, restaurant and the parking area in December 2013 and January 2014.

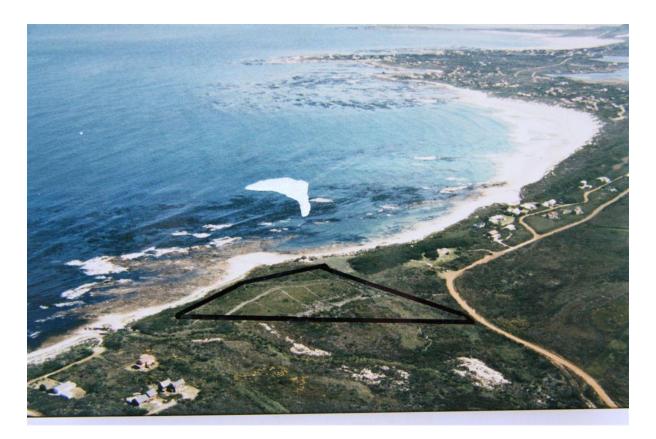
Figure4:

- As Fig 4 clearly shows, this wouldinterfere with the natural functioning of the entire lower floodplain and the formermajor flow channels entering the sea at the western end of Marine Drive, would just become more overgrown. Unpredictable ecological consequences will inevitably arise.

Aerial view of the seaward portion of the lower Disa River floodplain taken. This extremely interesting photo was provided by Richard Starke and depicts the lower floodplain ±1982. Dawidskraal Road is still intact, but it can clearly be seen that it cuts right through the original floodplain and that part of the original flow channel was simply filled in during construction of the road. Equally interesting is the fact that the lower portion of this flow channel is virtually straight and that it is situated at least 50 m away from milkwoods of the Dawidskraal Picnic Area (compare with the current situation in Fig 5). Note also that at that stage the bulk of floodwaters from the HPNBG flowed through a major flow (or river channel) entering the sea at the western end of Marine Drive). Further observations:

- a. When the photo was taken, the lower floodplain still functioned as a braided multi-flow channel system .
- b. However, three larger flowchannels can be discerned clearly on the photo. The largest one can be seen at the lower border of the photo. It is joined by another flow channel (approximately parallel with Waterfall Road) just before it enters the sea at the western end of Marine Drive. The flow channel immediately to the east of Dawidskraal Picnic Area is small and shows NO signs of meandering. It only became a major flow channel during the 2005 flood event when Dawidskraal Road was washed away entirely. The powerful meandering of this flow channel now threatening the milkwoods of the picnic area (Fig 5), only started once major water flows, coursed down this channel rather than down the original major flow channel to the east.

- c. A number of plots had been laid out at the edge of the dunes at the lower end of the floodplain, but no building had begun.
- d. Otter Close Road can just be discerned as nothing more than a jeep track. It is unlikely that it acted as a dam affecting water flow in the floodplain at that stage. Unless this, now much larger, road is provided with adequate culverts, it will continue acting as a dam, which probably enhances the meandering tendencies of the Dawidskraal flow channel

- 3. The existing but damaged weir ('keerwal') at the seaward, western side of the R44 bridge, must be rebuilt to direct the bulk of floodwaters into the former major flow channel entering the sea at the western end of Marine Drive (Fig 4). This will drastically reduce the amount of floodwater in the 'Dawidskraal flow channel'. Thereby swamp vegetation will be allowed to re-establish itself progressively along the Dawidskraal channel banks. With reduced water flow, the newly built, culverted Otter Close Bridge will be protected from further flood damage.

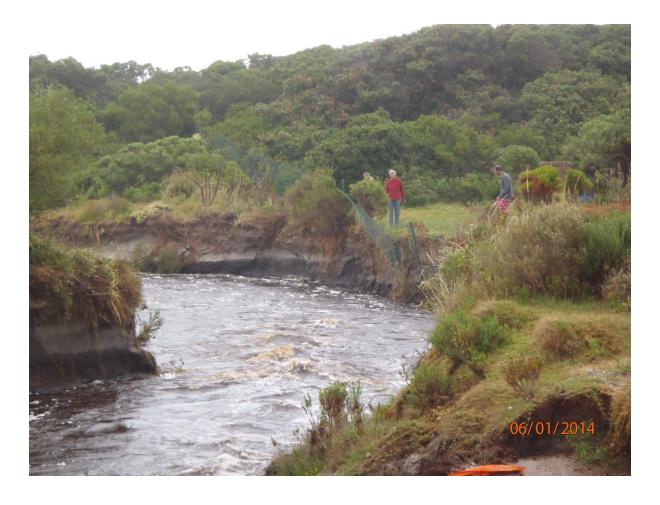
Figure5:

- As Fig 5 shows, erosion at the Dawidskraal corner is already extreme. It was vaguely suggested that gabions could be used to control this erosion. Examples in numerous areas along the coast make it abundantly clear that gabions seated on soft substrates are of no use in such situations, as floodwaters simply scour under and around them. Gabions used to re-enforce a former Otter Close Bridge provide a good example they were simply washed away. Were the bulk of floodwaters to be sent down the already seriously eroded Dawidskraal flow channel, this would spell the end of at least part of the ancient Dawidskraal milkwood forest and also of the public picnic facility itself. In no way would this solve the access problems to Otter Close properties.

This photo was taken at the height of the flood on 6 January 2014. Note that the raging floodwaters are approaching the Dawidskraal milkwoods at virtually right angles. Erosion in this corner is extreme and both the ancient milkwoods and the picnic area itself are under serious threat. Note also that the fence of the Dawidskraal picnic area is collapsing into the river due to erosion of the bank. Compare this situation with the configuration as it was in 1982 (Fig 4).
